CONSERVATION OF THE MAUSOLEUM OF SHAHZADA ABDULLAH IN KUHANDIZ, HERAT

Jolyon Leslie

An initiative in Herat between 2016-18 aimed to address this erasure of history through conservation of a monument that has religious and social value for the population, as well as being of architectural importance. The works were implemented by the Afghan Cultural Heritage Consulting Organisation (ACHCO) in collaboration with the department for Safeguarding of Historic Monuments of the Ministry of Information and Culture of the Islamic Republic of Afghanistan, and the Association for the Protection of Herat’s Cultural Heritage. Financial support was provided by the US Department of State through the US Embassy in Kabul.

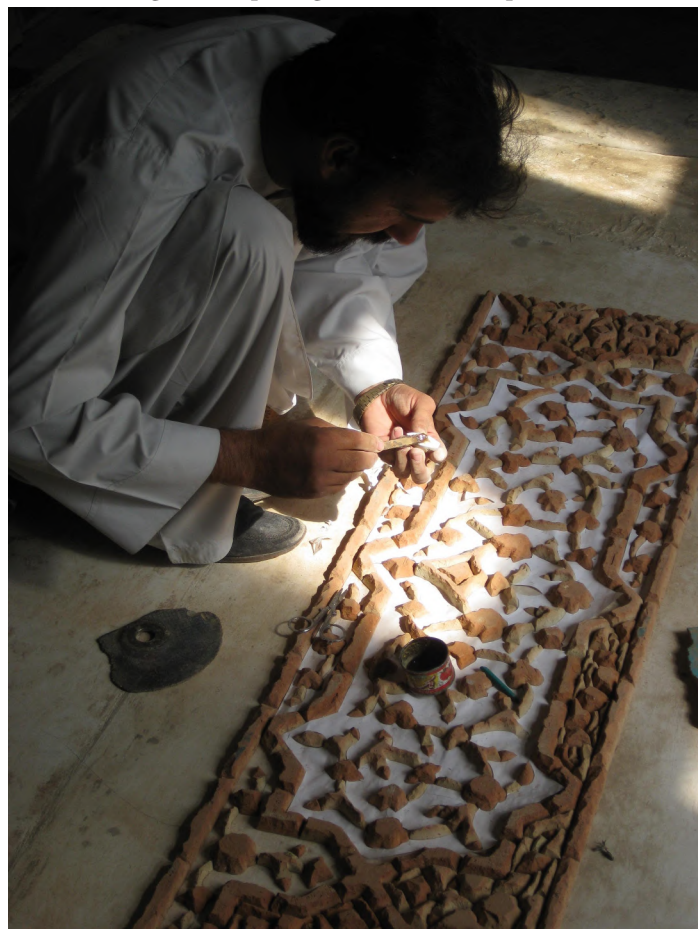
Fig. 10. Preparing mosaic faience panel.

tern in contrasting colours.¹ The shaped tile pieces were then placed edge-to-edge face down on a cartoon (possibly on paper) of the design, with a slurry of gypsum plaster then poured over the beveled backs of the tiles. Once the gypsum set, the panels would have been lifted and placed in position on walls or other surfaces.

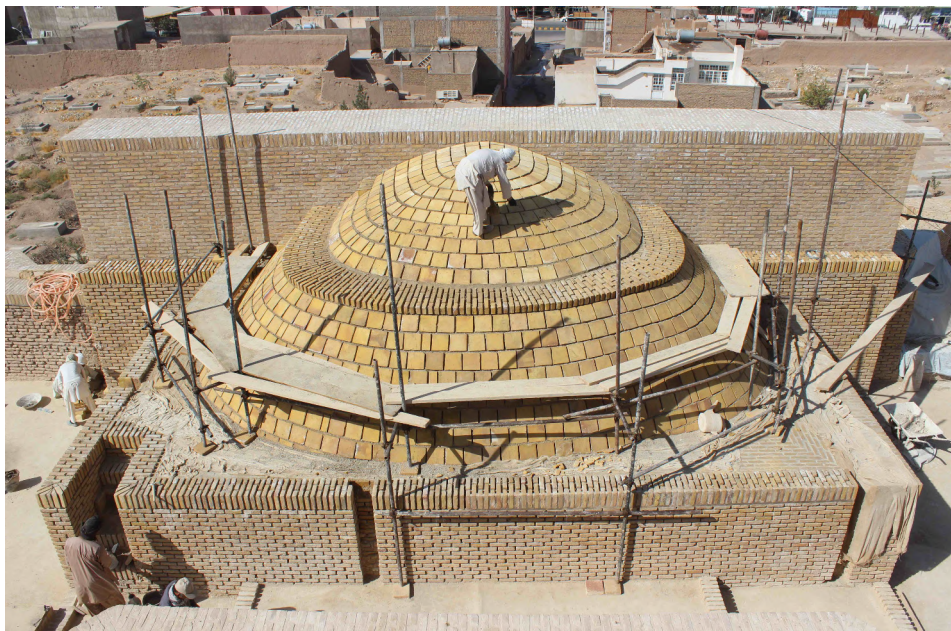
Fig. 11. Brick paving over reconstructed west iwān.

The initial focus of conservation work was on the west elevation of the mausoleum, where structural cracks were visible in the semi-dome over the entrance. This area suffered significant damage during fighting in the 1980s, when the building served as a vantage-point for government snipers. The removal of layers of *kahgel* (earth and straw mix) from the semi-dome exposed a fragile structure of half-bricks laid in gypsum/earth mortar, apparently part of repairs hurriedly undertaken at that time. After taking measures to ensure the stability of the supporting arch of the *iwān*, the entire semi-dome was dismantled in stages and, having removed an embedded reinforced concrete beam, the original masonry at the springing was exposed. During its reconstruction, flat stone plates were laid at intervals within the supporting walls to provide an effective structural connection, with lengths of durable timber (*binowsh*) laid horizontally in places to add strength. Once the reconstruction of the semi-dome was complete, it was sealed with a lime slurry before application of a layer of lime concrete (comprising lime, fine sand,

brick and charcoal dust, bulrush fibres mixed with water) that was manually compacted with rubber hammers over two days. Fired brick paving was then laid to form a durable roof surface. While historic photographs indistinctly show patterned decoration in the soffit of the semi-dome, no trace was found during these works of either plaster or tiles, indicating that the entire upper section of the *iwān* had been comprehensively re-built at some stage in the past.

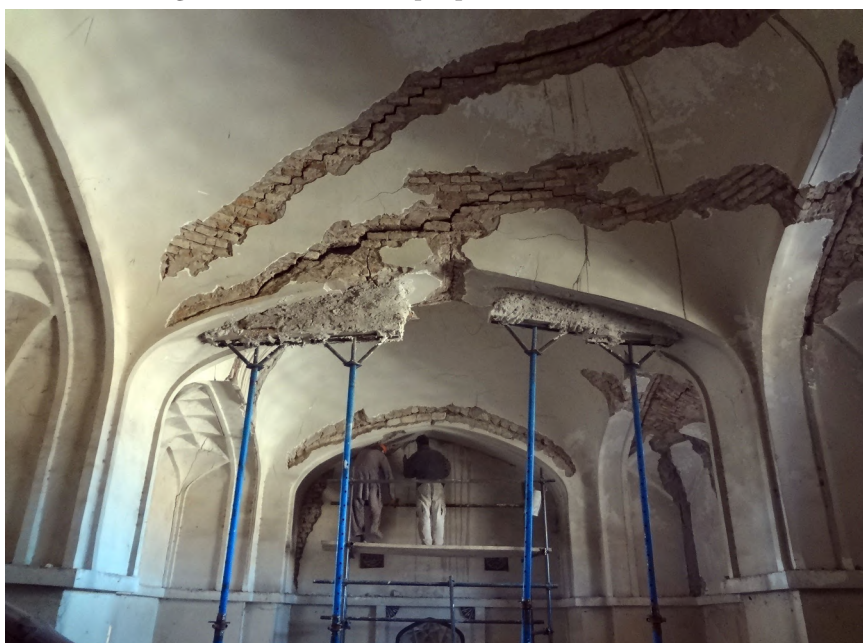
Fig. 13. Interior of mosque prior to reconstruction.

Surveys revealed serious cracks in the mosque in

the north-west corner of the mausoleum, with historic photographs indicating re-building in this area in the 1960s or earlier. In order to assess the stability of the masonry structure, layers of earth material were removed from the roof. The large quantity of spent ammunition found buried in this material bears out accounts of the building being used as a vantage-point in the conflict in the 1980s, when vibration from artillery is likely to have weakened the brick structure. The discovery of fragments of a broken masonry arch suggests that the

structure had collapsed in the past. Removal of the internal plaster revealed evidence of major alterations to the layout of the mosque that may also have affected its structural integrity. Traces were found of internal openings on two levels, with an intermediate floor having been removed. It is unclear why this transformation was made; it is conceivable that the original builders envisaged another function for this space, only for it to subsequently be converted into a mosque, for which greater volume was felt to be necessary.

Despite having been re-built in the past, the outer walls of the mosque were unstable, requiring consolidation of the stone foundations before the two domes and supporting arches that span the mosque were dismantled and reconstructed following the original geometry. Again, lengths of durable *binowsh* timber were laid in the masonry at regular intervals to provide additional strength.

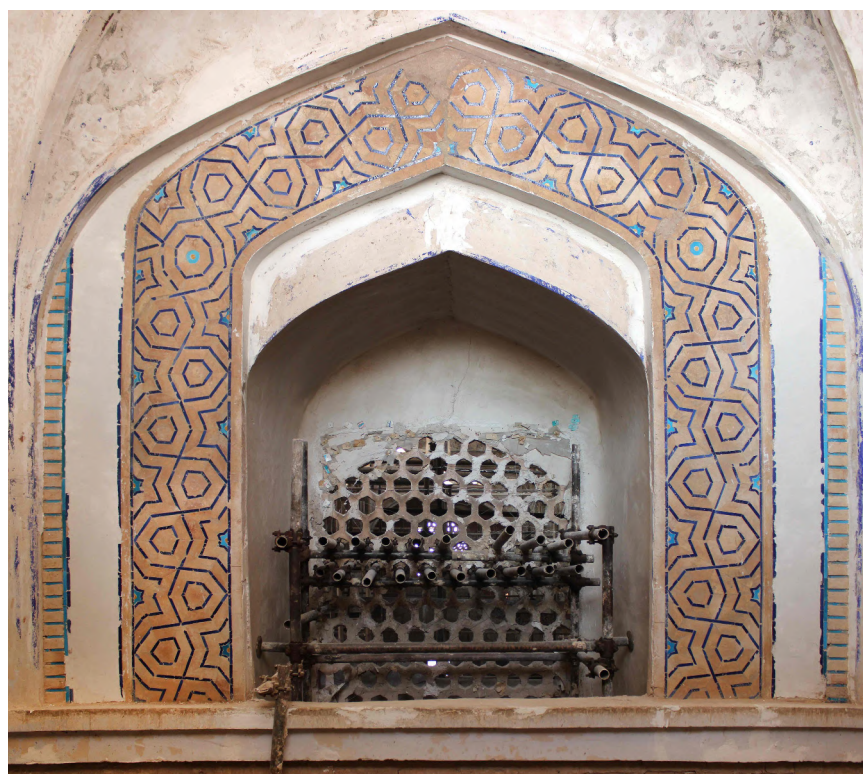
Fig. 14. West iwan decoration.

Subsequent work at a lower level of the west *iwān* revealed that the original Timurid tile decoration within the arched opening extended to ground

level, before it had been concealed by insertion of a small entrance lobby in the early 20th century. This decoration suggests that the *iwan* had originally been open, for no evidence of fixings for doors or screens were found. Along with the east *iwan*, where tilework (to a different pattern) was also found at ground level, their enclosure represents something of a transformation from how the Timurid-era builders seem to have conceived the mausoleum.

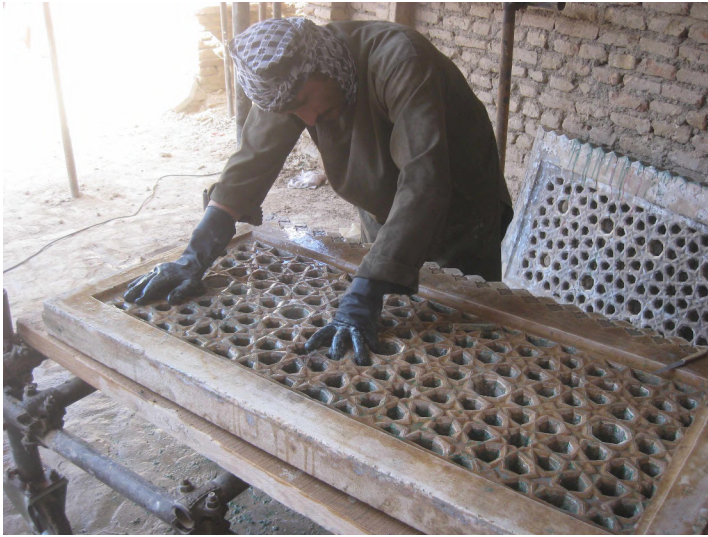
Fig. 15. Cleaning marble panel.

head facing north), others appear to have been laid at random. After documentation in situ, the latter group was re-located elsewhere in the building, with the agreement of the custodian. A number of marble elements around the base of Mu'awiyah's grave had insets that seem to have housed posts, as part of a balustrade. Several such posts were found discarded elsewhere, along with fragments of marble lattice panels (similar to balustrades at the shrine complex of Abdullah Ansari in Gazurgah). One intact panel was cleaned of modern oil-paint and re-installed beside Mu'awiyah's grave.

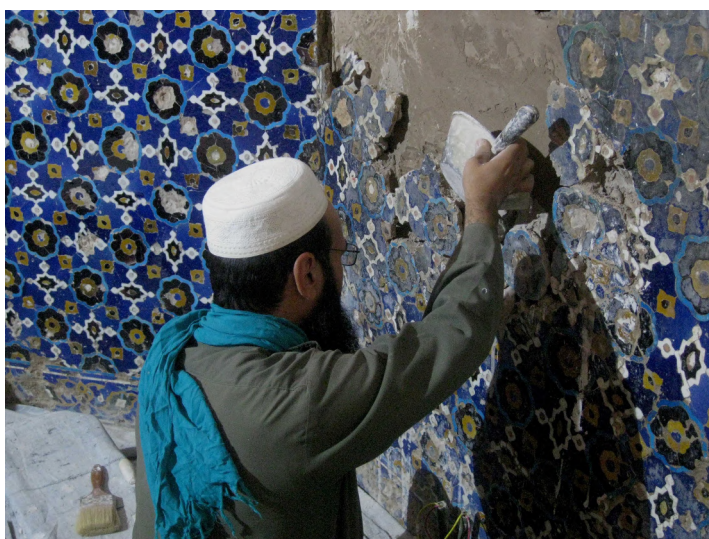
Fig. 19. Pouring gypsum plaster behind unstable mosaic faience.

Several panels had been affected by damp in the supporting wall, causing bulging and eventually disintegration as the gypsum bedding expanded and lost strength. These areas were dismantled and, where the original tile fragments could be retrieved, re-assembled in situ. Elsewhere, gypsum was injected behind the panel (in apertures left by missing tiles) to bond loose areas back to the supporting masonry.

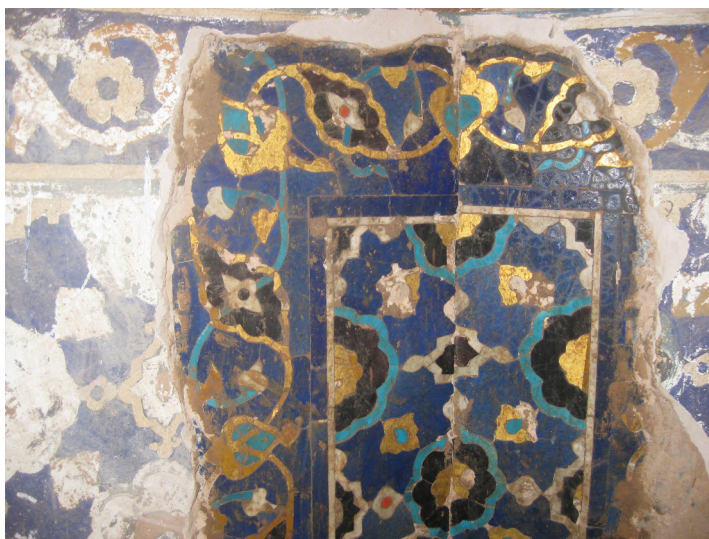
Fig. 20. Mosaic faience concealed behind plaster.

No attempt was made to “reconstruct” missing sections using modern components, as it was not possible to match the original glazes. The sections of plaster in imitation of tilework have been retained, on the understanding that they are part of the mausoleum's history, with some areas repaired flush and left unpainted to distinguish them from earlier interventions.

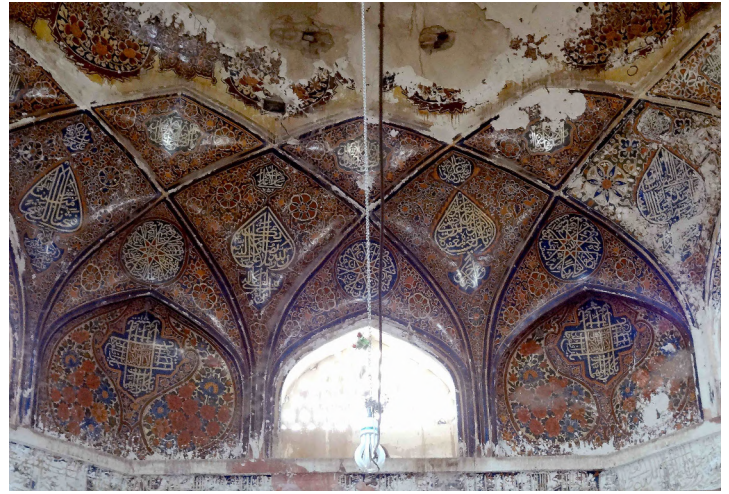
Fig. 22. Painted decoration on springing of central dome.

The interior of the central space of the mausoleum, including the soffit of the dome, is decorated with paint applied to gypsum plaster. Traces of plain ochre plaster (as found on the *muqarnas*) under lower sections of the painted decoration

suggest that this is a modern alteration and that wall surfaces at this level may originally have been plain.

The painted decoration on the soffit of the central dome was found to be in poor condition, with large areas of loose plaster and some of the paint peeling off despite previous application of varnish. The materials and techniques used in this decoration suggest that it is a later transformation, and it is likely that the soffit of the dome was originally finished with plain ochre pigment as used on the *muqarnas*. A skim coat of pigmented plaster was applied to fragile areas of the dome where no decoration survives. Aside from detailed documentation and removal of accumulated dust from the surface, no further work was carried out on the painted decoration, whose fragile condition requires specialist restoration. Similarly, no work was attempted on the band of calligraphy below the
