SAMARQAND REFASHIONED

A TRAVELLER'S IMPRESSIONS, AUGUST 2013

Elena Paskaleva

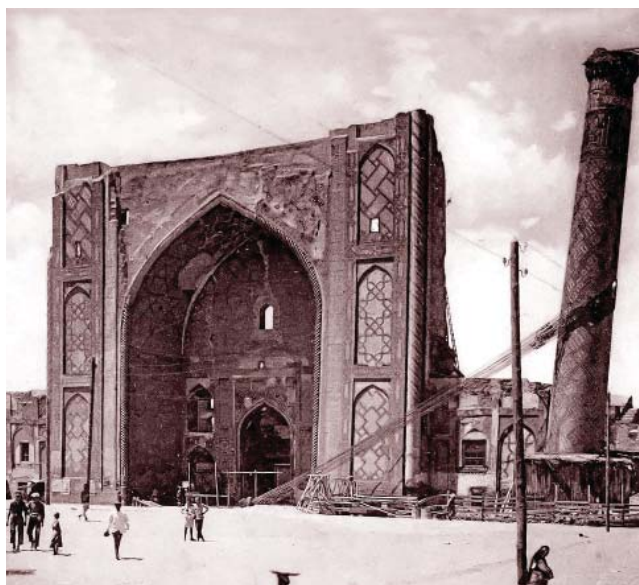
Fig. 2. The straightening of the northeastern minaret of the Ulugh Beg madrasa in 1932. (Source: <<http://mytashkent.uz/2012/12/09/k-80-letiyu-vypryamleniya-minareta-vladimir-grigorevich-shukhov/>>.)

(1922–1932), the northeastern minaret was straightened in 1932 (Fig. 2) based on the second plan by the Moscow engineer Vladimir G. Shukhov and with the technical assistance of G. I. Solov'ev (Masson 1968). In the 1950s E. O. Nelle produced the drawings for the straightening of the south-eastern minaret, the work executed by the engineer E. M. Gendel in 1965 (Kriukov et al. 2004, p. 574).

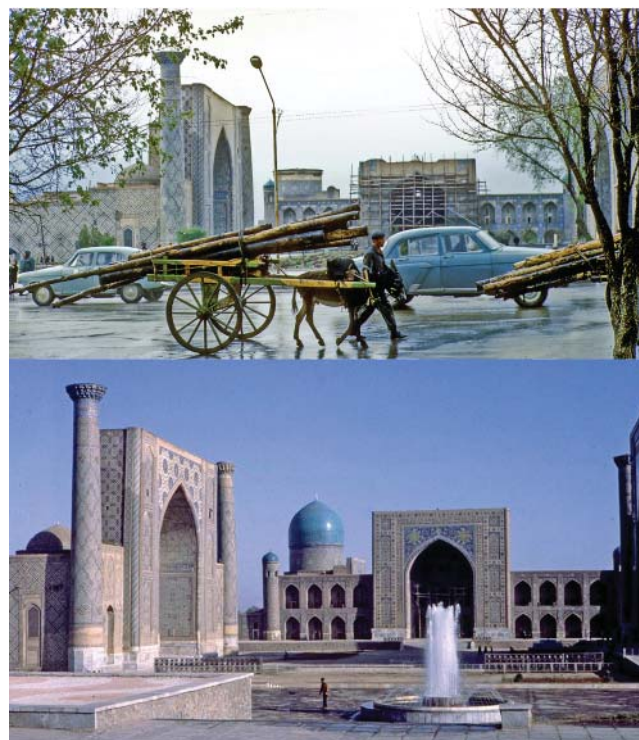
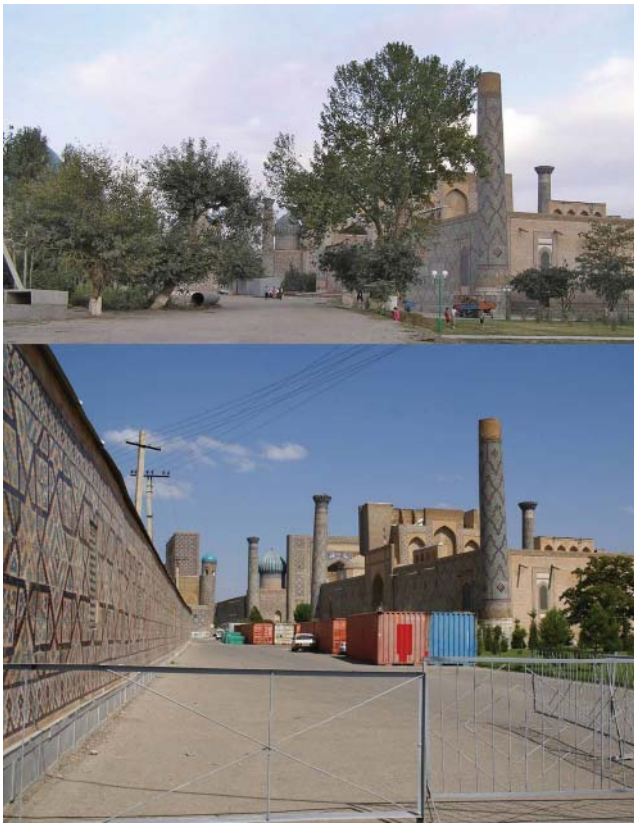
Fig. 4. View along northern side of Ullugh Beg madrasa in 2005 (photo courtesy of Gwen Bennett) and after the erection of the wall in 2013.

manship. Although relatively new, the wall is in a very bad state of repair, due to rainwater from broken gutters. Its straight vertical lines have caved in at several spots, which has resulted in unusual curves and bulges with decorative bricks already breaking and falling down, and glazes wearing off.

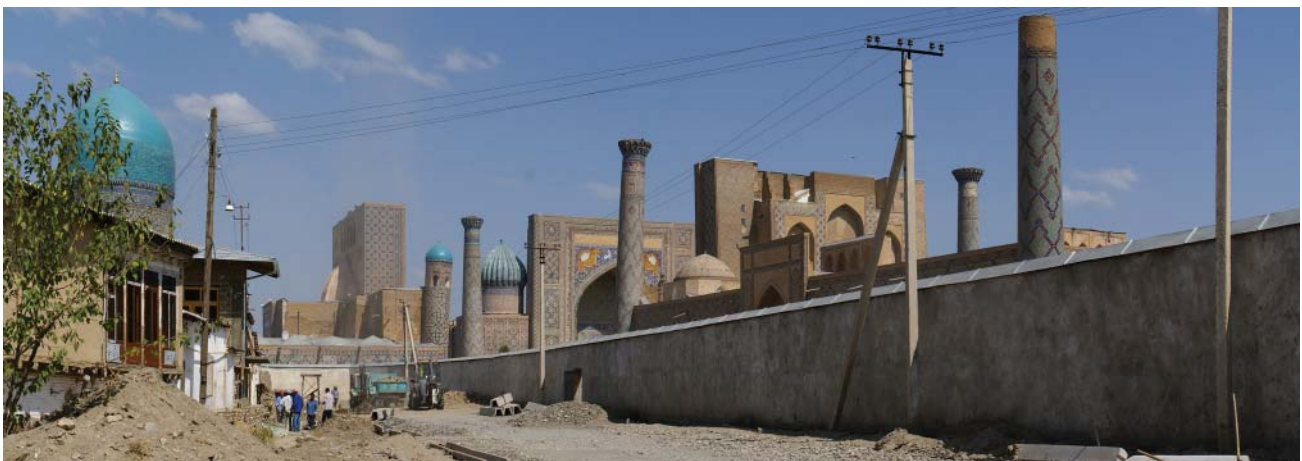
Fig. 5. Composite image showing the north side of the Registan wall, with work underway on the new road and the destruction of the adjoining houses in August 2013.

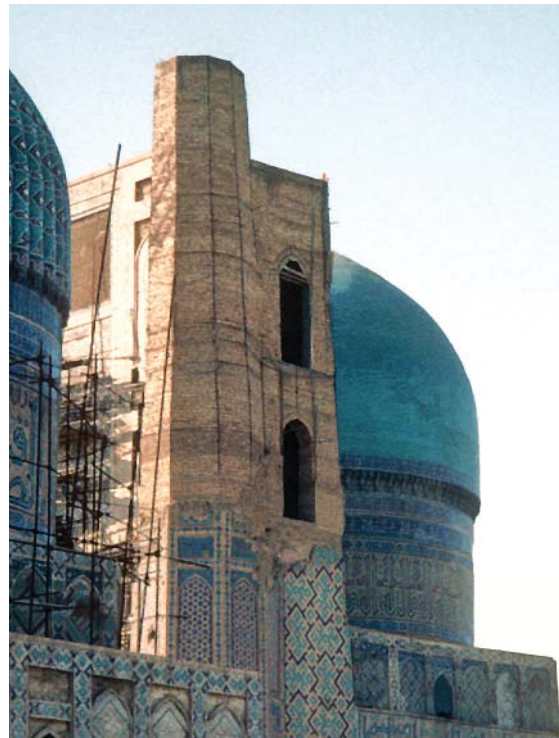
Fig. 12. View of the Bibi Khanum from the northeast, showing the newly constructed pylon of the main sanctuary whose upper part had not yet been re-decorated with new tiles. (Photo © 1991 Daniel C. Waugh).

period, who initiated the replacement of all brick load-bearing structures with reinforced concrete frames (Demchenko 2011, p. 73). Throughout the 1980s and 90s the collapsed domes of the side mosques were rebuilt with reinforced concrete and new tiling was inserted along the domes' ribbed outer shells. After 1985 the main sanctuary was adorned with massive pylons, decorated in mass-produced tiles (Fig. 12). By the end of the 1990s the epigraphic programs were executed anew. The new Koranic epigraphic band on the main sanctuary at Bibi Khanum contains Sura Al-Baqarah (The Cow), Aya 127/128 (Fig. 13, next page). It is interesting to note that exactly the same text can be found above the entrance to the Gok Gunbad Mosque in Shahr-i Sabz, initially commissioned by Timur's grandson Ulugh Beg (1435–36) and rebuilt after Uzbek independence. The present Koranic epigraphy of the exterior and interior of Bibi-Khanum, Gok Gunbad and other Timurid monuments, was designed by the Uzbek calligrapher Habibullah Solih. It is possible that during the restoration campaigns similar calligraphic templates were reused for completely different monuments, situated in different cities and dating from different centuries.

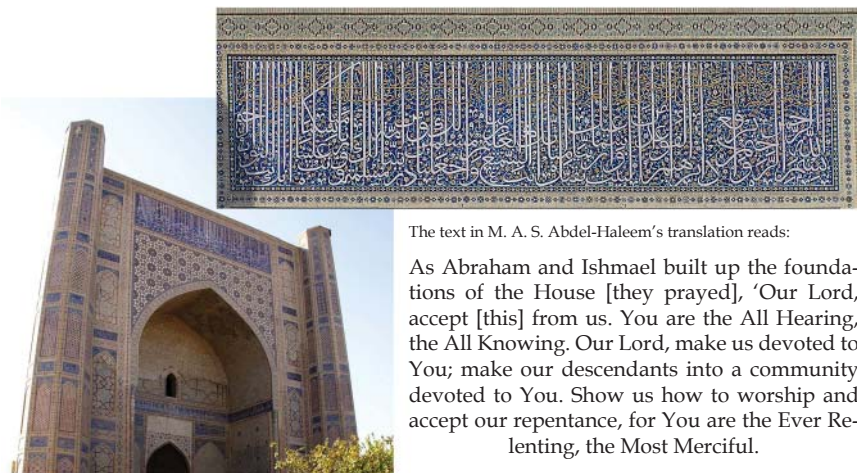
Fig. 13. The Koranic epigraphic band above the iwan of the main sanctuary of Bibi Khanum. (Photo by author and the detail courtesy of Gwen Bennett.)

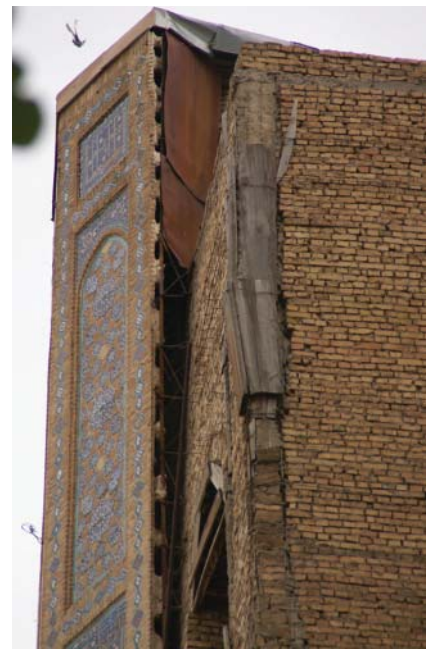
Fig. 15 (right). View of the back section of the iwan screen of the Bibi Khanum, showing separation between it and the reinforced concrete of the towers, 2013.

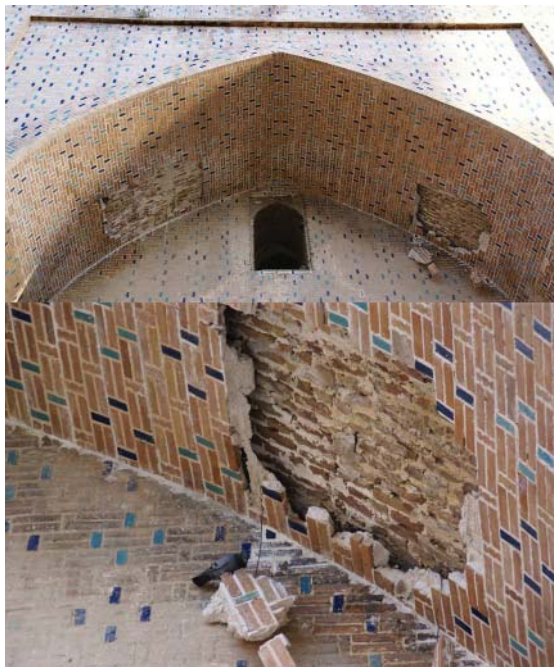
The modern bricks forming the arch are falling down (Fig. 14). The northern small mosque, open to tourists, has been turned into a dusty, unwelcoming souvenir shop with wobbly floors and old unframed pictures hanging on the walls. The state of the main sanctuary is alarming. One can now see colossal holes between the two massive polygonal towers rebuilt in reinforced concrete and the back side of the *iwan* screen (Fig. 15). Rain water is continually penetrating the sanctuary through broken gutters. The dome had been severely damaged by the earth-

Fig. 14. The iwan arch of the southern small mosque of Bibi Khanum, with its disintegrating brickwork, 2013.

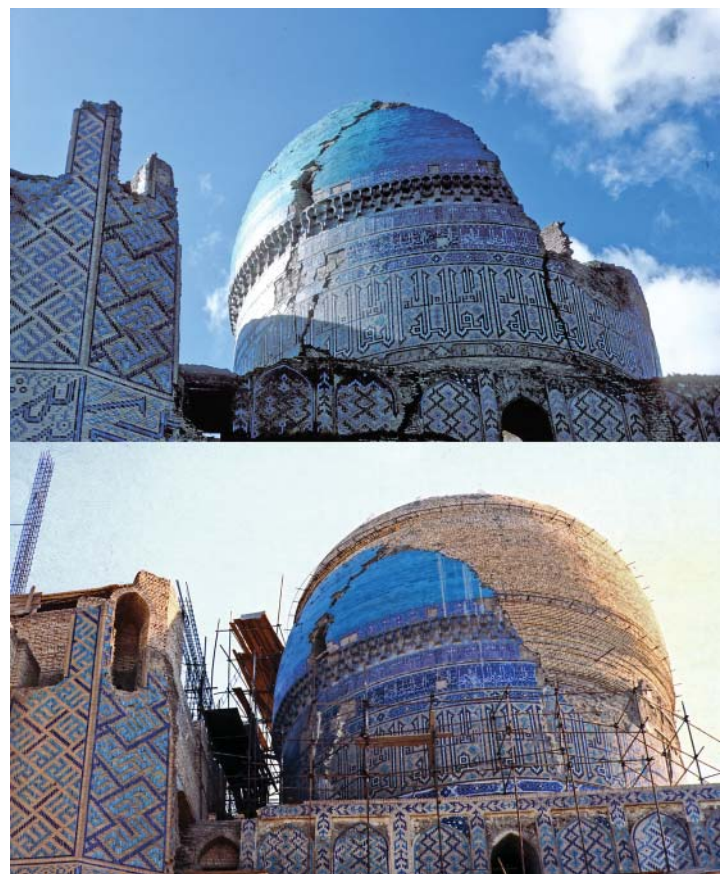
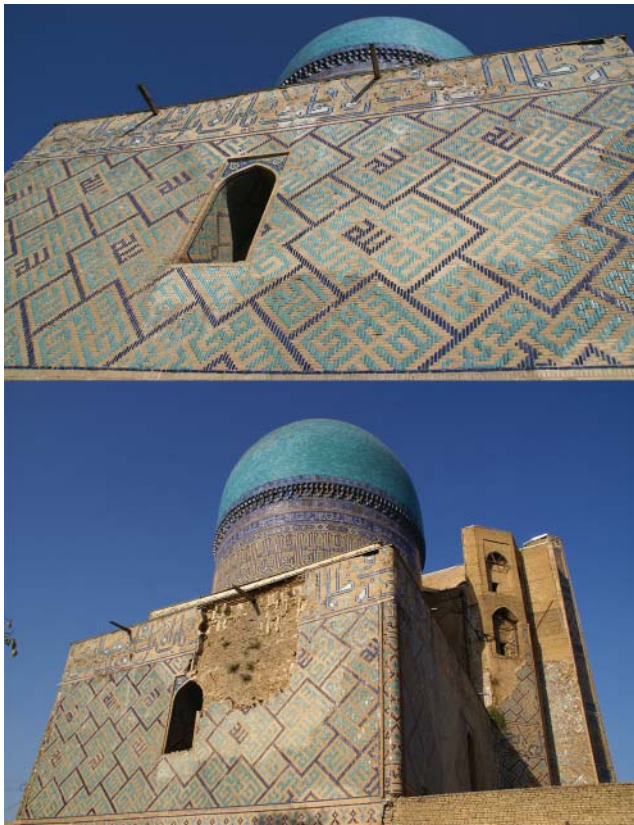
Fig. 17. Back side of the main sanctuary of Bibi Khanum in 2006 (top) and in 2013.

A huge piece of the original Kufic script on the outer western wall of the Bibi Khanum sanctuary has vanished in the last five to six years (Fig. 17). The wooden gutters are broken, so that rain water flows directly along the wall. Moreover, the back side of the mosque is exposed to fumes and road vibrations from the traffic to the nearby Siyob bazaar (Fig. 18). The bazaar, which is in a sense emblematic of Samarqand, has always been a major tourist attraction. It is accessed currently through Chorraha Street, which runs right along the back of the Bibi Khanum sanctuary. The proximity of this narrow and yet very busy road with extensive fumes from old Soviet cars, is a real threat

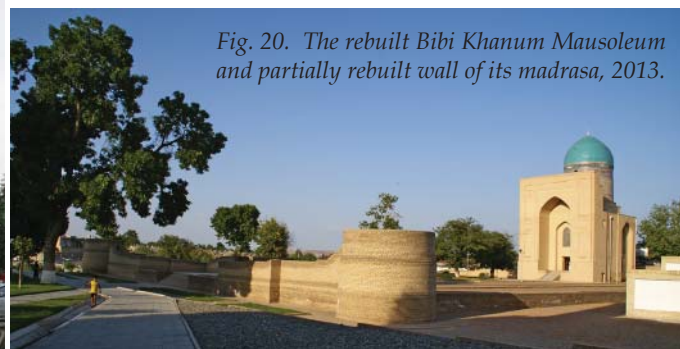
During the urban regeneration of Samarqand prior to the 2007 celebrations, the whole square between the Bibi Khanum Mosque and the Bibi Khanum Mausoleum (15th century) was completely refurbished. In 2005–6, the mausoleum, which had been reduced to ruins (Fig. 19), was adorned with a new pseudo-Timurid dome on a high drum and rebuilt facades with arched portals. The outer wall of the Bibi Khanum madrasa was built up above ground level with modern brick, to replicate the presumed position of the original *guldastas* (corner towers) (Fig. 20).

Fig. 20. The rebuilt Bibi Khanum Mausoleum and partially rebuilt wall of its madrasa, 2013.

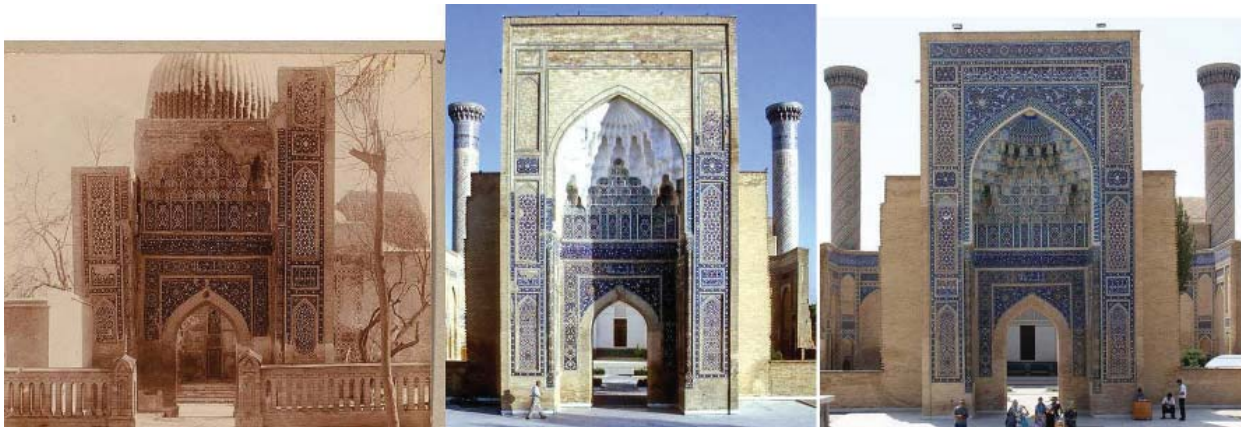
When I saw the Gur-i Amir portal for the first time in September 2006, Iosif I. Notkin's 1950s brick restoration was intact (Fig. 27). In the 1950s the founda-

Fig. 27. Restorations of the main entrance to Gur-i Amir. On left, photo by Sergei Prokudin-Gorskii, 1905–1910; in center, in 1999; on right, in 2013. (Sources: Library of Congress <<http://lcweb2.loc.gov/service/pnp/prok/02200/02290v.jpg>>; © 1999 Daniel C. Waugh; author.)

tions of the gate had been stabilised with reinforced concrete and the damaged *muqarnas* (stalactite vault) restored (Kriukov 2004, p. 459). The first pictures by Prokudin-Gorskii from around 1910 show the state of the main entrance prior to the Soviet interventions. After September 2008 the whole *iwan* surface was tiled and a Koranic inscription was added above the archway. The text is Sura 'Ali 'Imran (The House of Imran), Aya 104. The addition of newly designed epigraphy seems to be a common practice in present Uzbekistan. The monuments turn into a landscape of layered restorations, each political regime leaving its own mark based on its own ideology. Unfortunately, the approach of Zasyarkin, who insisted that all tiles be inserted by hand on the Gur-i Amir dome and was constantly present on the site to assure this was properly done, has been replaced by the desire to present mass-produced fictional works of art to the flocks of international tourists. The fact that this epigraphy is being added after the monuments had been listed by UNESCO as World Heritage in 2001 has been conveniently forgotten.

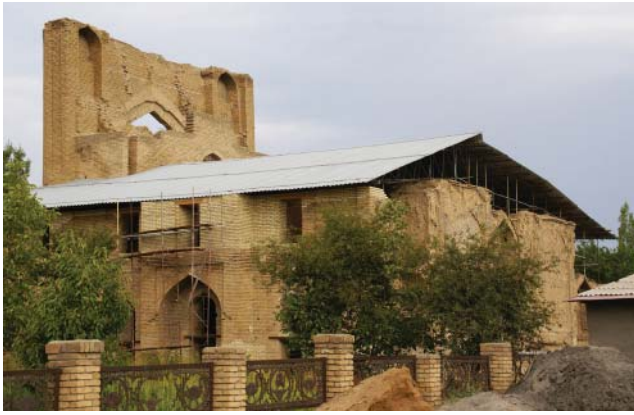
Fig. 35a, b. The Ishrat Khaneh under reconstruction, 2013, where the contrast with Pugachenkova's photo from 1963 demonstrates how much of the interior decoration is being created de novo.
